Final Report

Prepared for: Stephan Robinson, Green Cross Switzerland

December 5, 2014

“Mitigation of acute lead exposures in Dong Mai Village, Vietnam”

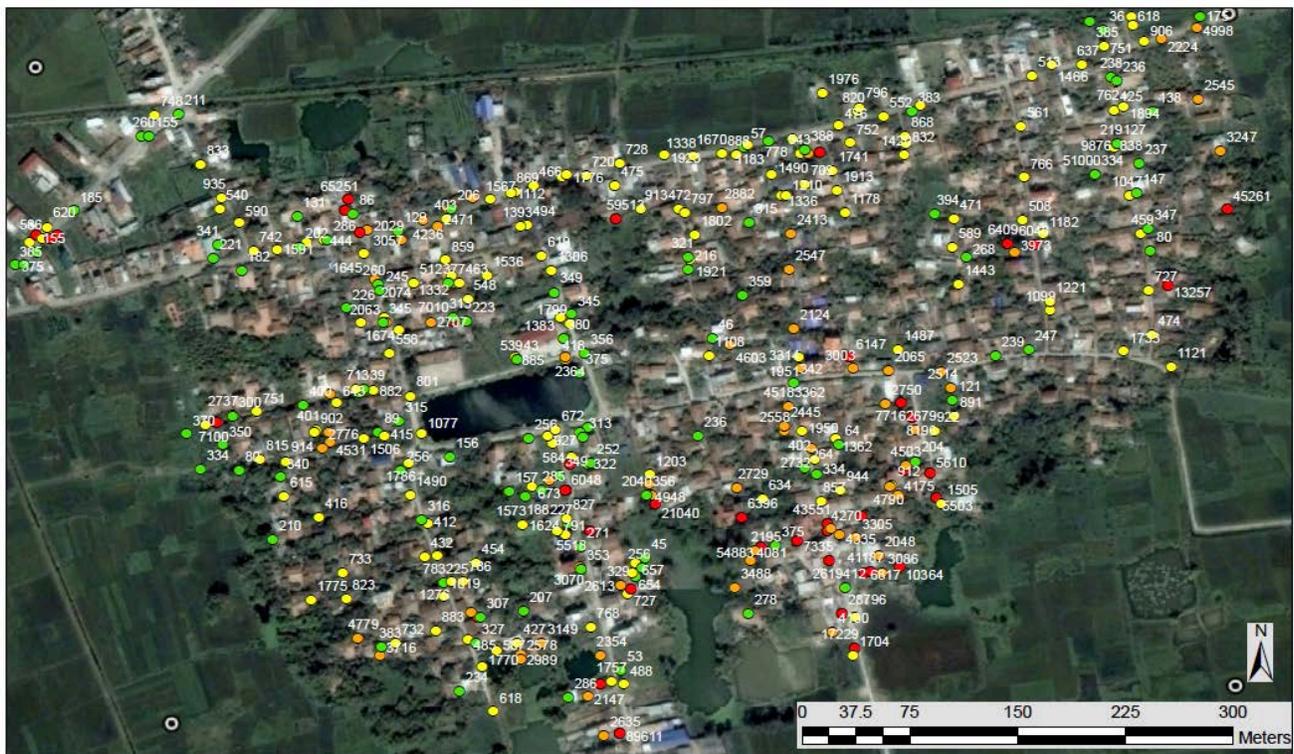
Map of soil lead levels in Dong Mai. Lead contamination in Dong Mai was extensive, presenting a challenge in remediation design. The elected approach was one of triage; targeting acutely dangerous areas and catalyzing community action through education.

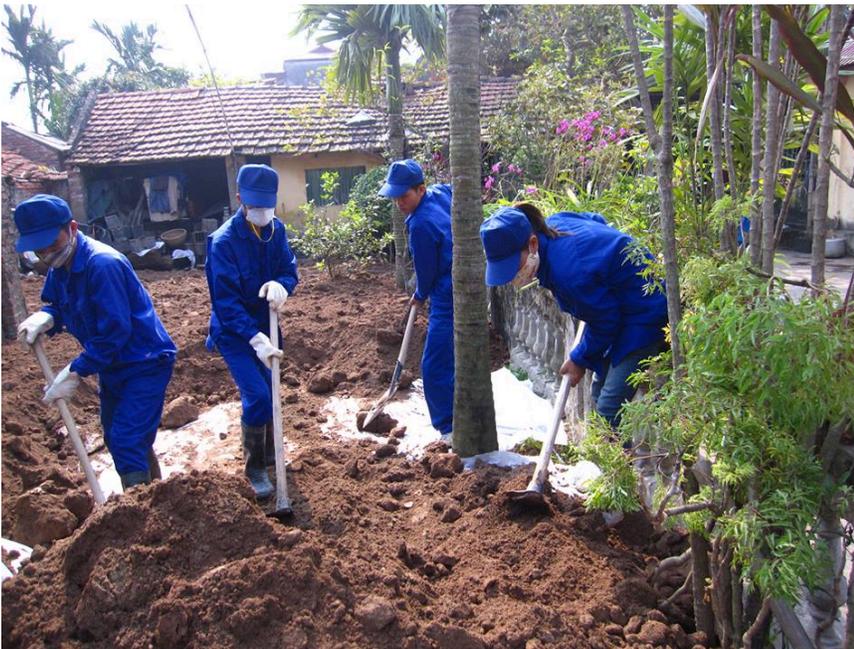
Yards with lead levels above the threshold of 800 ppm were capped with a geotextile layer and compacted clean soil.

Of the 42 homes, 23 exceeded 1200 ppm, with the average for this group around 4,000 ppm and the high above 20,000 ppm. 39 of these houses were remediated during the project. The remaining 3 were large enough that including them would have been to the exclusion of all of the others. They were therefore not included. At least one of these home owners elected to carry out remediation with his own funds.

To mitigate the risk posed by residential soil, the team elected to cover contaminated soil first with 5 cm of sand and second with a geotextile layer. This was then covered by either 20 cm of sand, 20 cm of compacted clean soil, pavers (bricks), or concrete. The alternative would have been to remove and landfill the contaminated soil at USD 400 per m³. Given the scope of the soil contamination, this would have been prohibitively expensive and incurred additional risks in transit. Soil capping (in-situ encapsulation) is a well excepted methodology recommended by USEPA among others and was appropriate in this case. Soil in Vietnam is comparatively expensive, as it is typically excavated alluvial. As a result, it only maintains a marginal cost advantage to concrete or pavers, thus the decision to use concrete or soil was made based more on intended use than other parameters. All soil levels are now ~50ppm in yards.

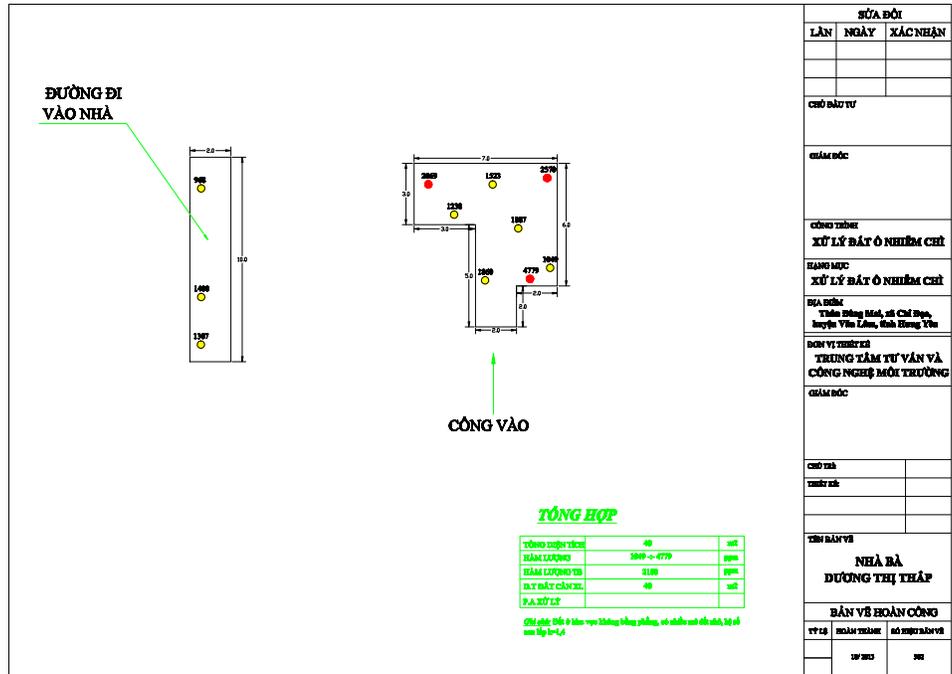
Most of the homes in Dong Mai are surrounded by concrete patios. These pose little risk as they are regularly washed and do not retain much lead. 261 homes have soil gardens. All of these were assessed with a handheld XRF. Sampling found that 42 gardens of the 261 gardens in the village exceeded 800 ppm at the beginning of the project. While the USEPA standard for lead in residential soil is 400 ppm, a decision was made to limit remediation activity to only those above 800 ppm. Mitigating exposures in the yards between 400 ppm

Each soil yard was characterized with a handheld XRF. Detailed diagrams were generated to inform design and planning.

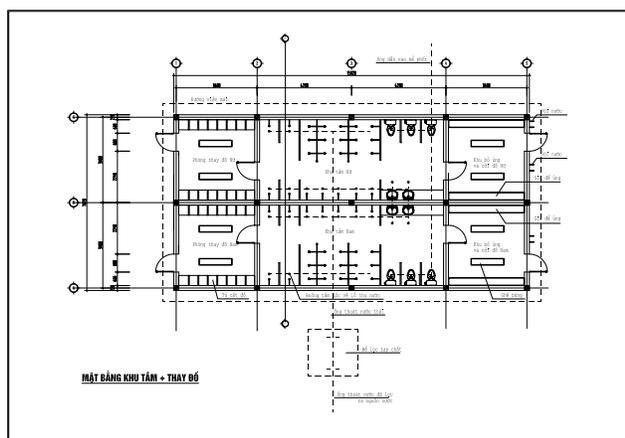
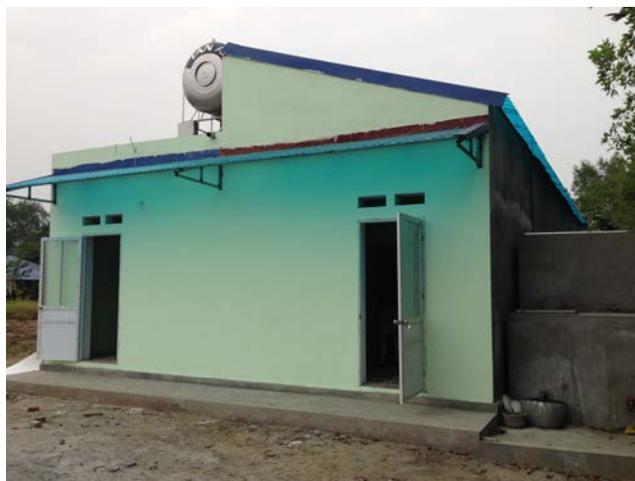
A changing facility was constructed to mitigate the take home risk. The design on the left was first drafted by and American architect than modified to meet local conditions. The foundation was poured August 7th 2014 and completed in November.

Although not identified as an activity in the original proposal, a changing room for workers in the industrial area was constructed as part of the project. The changing room was designed by ILMC and will help mitigate the migration of lead dust from the industrial zone to residential areas. It has showers, lockers and toilets and will be sufficient in size to for all workers to use. The facility was constructed in a joint effort with the major private smelter; Blacksmith co-financed 60% of the construction and the private facility covered the balance. This was made possible through costs savings during the project and through a concerted effort to engage the facility owner in the project.

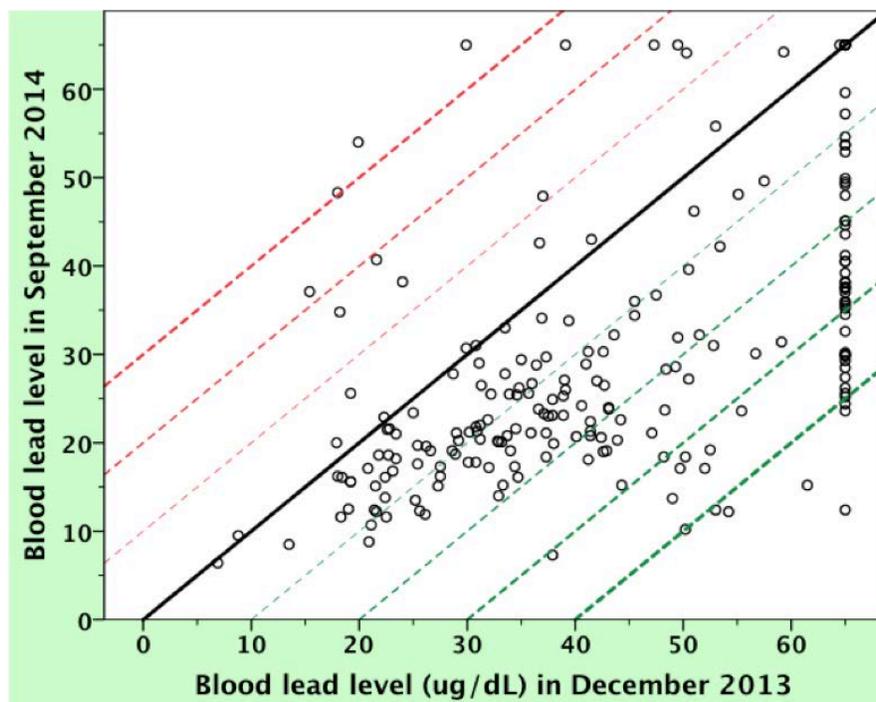
In addition to environmental sampling. Blood Lead Levels (BLLs) were taken from a total of 263 children on two separate dates (December 2013 and September 2014), with 209 of the same children participating on both dates. BLLs fell from an average of 39.1 ug/dL to an average of 25.35 ug/dl (35.17%). Declines were seen in all age groups and at all levels of exposure. The table below graphically summarizes the results of the 209 participants.

Blood lead levels before and after cleanup and community education. Green lines represent incremental decreases of 10 ug/dL. Red lines represent increases.

Remediation and education work were completed in March 2013. The graph above therefore represents gains made as a result of these components, though not those made by the construction of the changing room or road construction. This downward trend is expected to continue through 2015 absent further work.
