# Project Completion Report

19 January 2016

“Kabwe pilot lead remediation project”

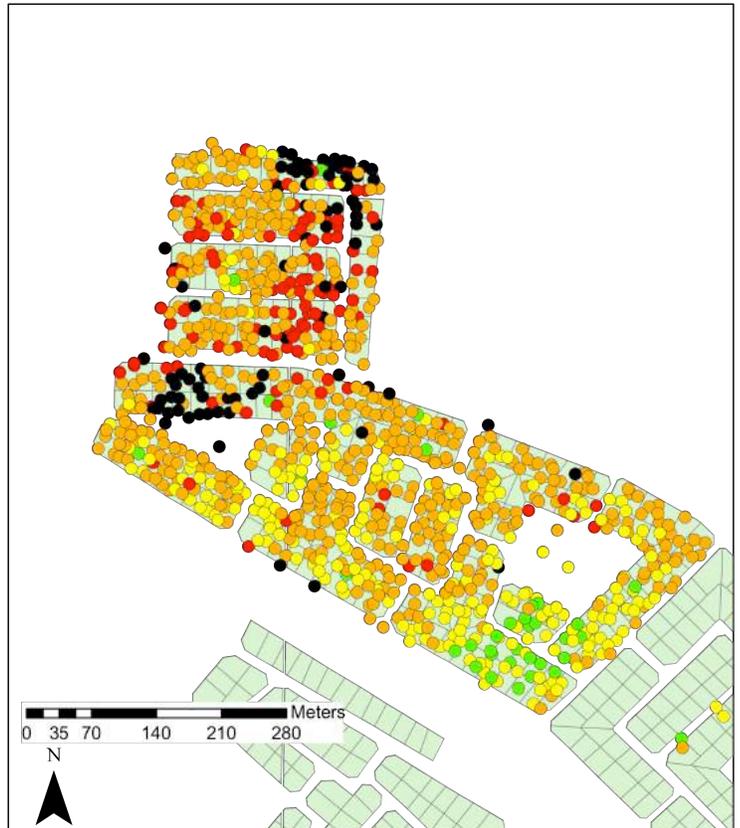
Chowa Soil Lead Levels  
September 2015  
Kabwe Municipal Council  
Pure Earth (NY, NY, USA)  
Environment Africa

Soil lead concentrations tended to be highest along the northern border of the neighborhood that is defined by a large drainage canal. Residents said this canal occasionally floods during heavy rains when it has not been

Soil Lead Levels (ppm)  
● <400  
● 401-1000  
● 1001-3000  
● 3001-5000  
● >5000

Above: A map of individual soil sample points created by Pure Earth staff, September 2015

adequately maintained, which has been a problem in the past. The lowest concentrations were found in the southeast section of the neighborhood that was furthest from the canal and the mine. In general, soil lead levels were between 2,000 and 4,000 ppm within the project area and between 1,000 and 3,000 ppm in the remainder of the neighborhood. Soil samples were confirmed with a laboratory analysis. Additionally, three municipal water samples were collected and analyzed within the project area to determine if water was a significant pathway. Lead was not detectable in all water samples analyzed, which is consistent with historical analyses.

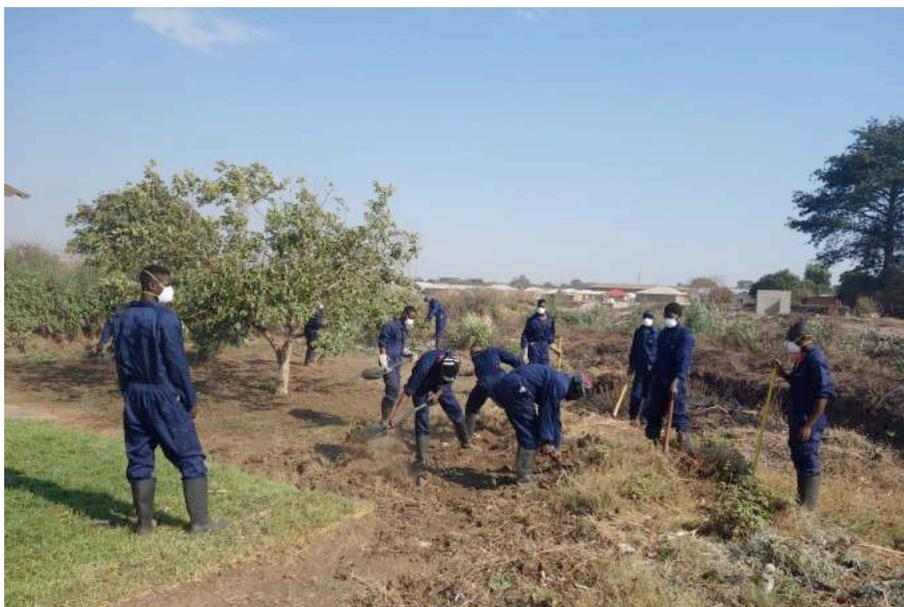
Above: One of several remediation teams prepares a yard for encapsulation with a barrier cloth

In September and October 2015, the teams leveled the yards of all 78 homes and also removed vegetation and obstructions (e.g. debris) that would interfere with the encapsulation process. It took approximately ten days to prepare each yard for the barrier cloth utilized in the encapsulation process. Once yards had been adequately leveled and cleared, cement pads were added to the entryway of approximately two thirds of the homes within the project area. The pads were installed to prevent erosion of clean soil outside the home as most homeowners sweep their doorsteps daily.

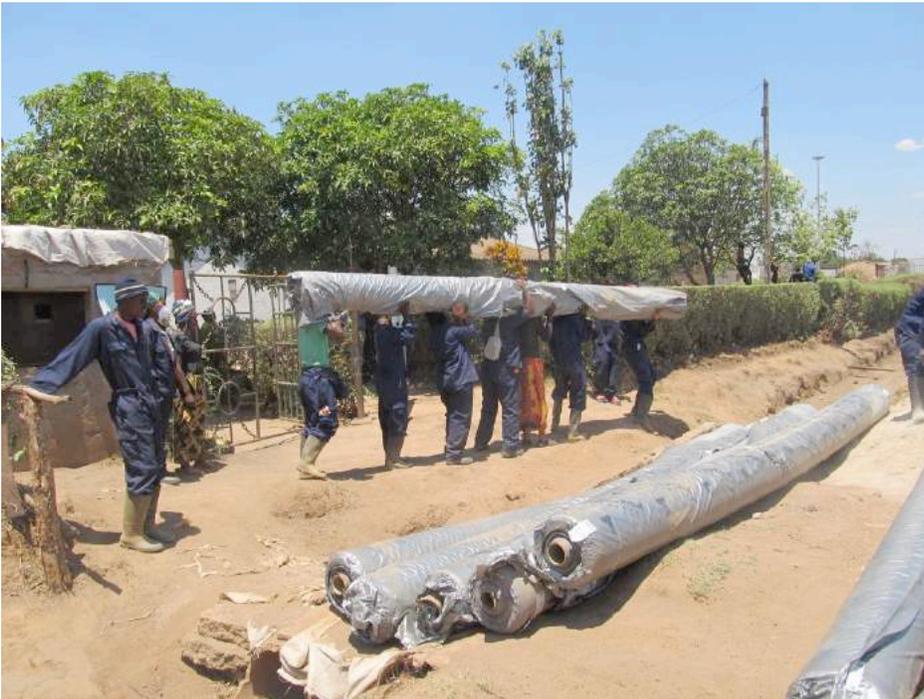
Above: A remediation team carries a rolled up barrier cloth, also called a geotextile layer, into the yard of a home to prepare it for encapsulation

In November 2015, remediation teams then consisting of 30-40 people completed the encapsulation process at all 78 homes. The teams first laid a geotextile barrier cloth (Fibertex F25) at each home where appropriate, avoiding areas where lead is already encapsulated (i.e. paved or gravel driveways, stone walkways, densely packed grass areas, etc.). This geotextile was then covered with approximately 10-15 cm of clean laterite soil. In addition to the yards, a frequently used and highly contaminated pathway between the project area and nearby roads,

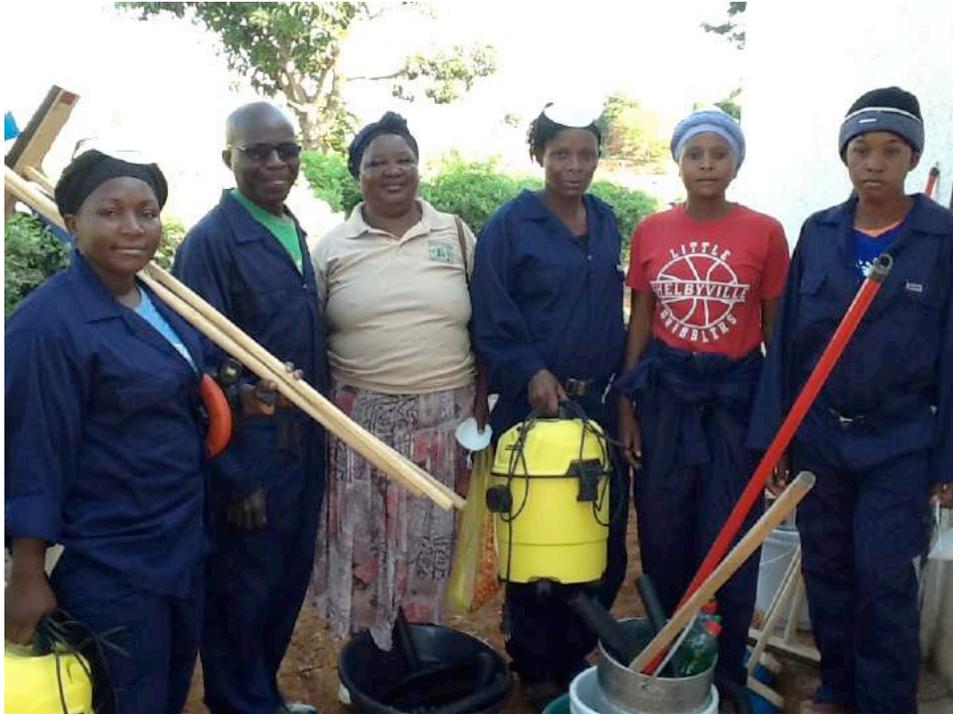
Above: One of the home cleaning teams with community outreach staff from Environment Africa

Once a yard remediation was completed, two ‘house cleaning’ teams of four people each entered each home and cleaned it with the assistance of a HEPA filter and soap and water to mitigate lead exposure via dust inhalation and ingestion. The insides of houses were found to be highly contaminated through XRF testing. This is believed to be a major risk as young children spend much of their time inside houses (as well as in yards). Cleaning could only be done after the yard remediation so that lead dust is not re-introduced into homes after cleaning.
