An Assessment of the Potential Presence of Carcinogenic Materials at Non-Military Industrial Sites in Vieques, Puerto Rico

Jack Caravanos, DrPH, CIH
Professor, Environmental Health
City University of New York, School of Public Health
(29 October 2015)

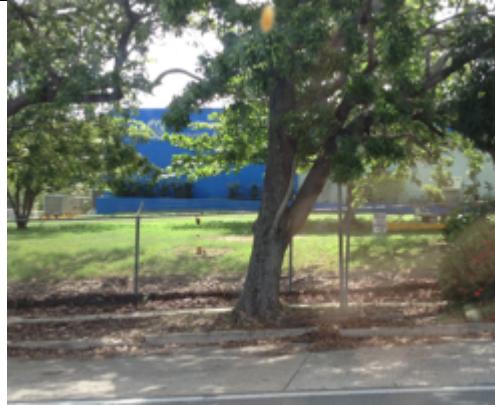
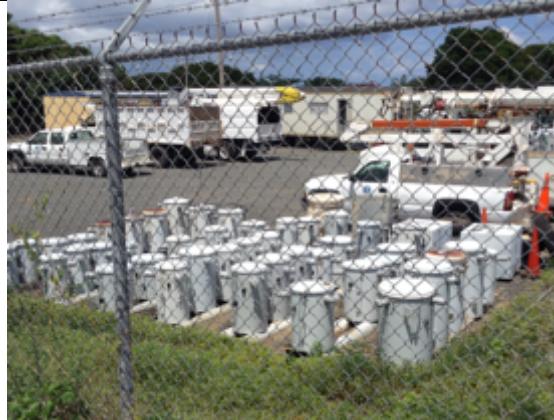
| GE Facility | GE Facility |

INDUSTRIAL FACILITIES: The islands only major industrial facility is General Electric (GE) Industrial of Puerto Rico LLC (property owned by Puerto Rico Industrial Development Corporation) on the north side of the island near the main population center (Lat/Long 18.14004, -65.45798). This small, approximately 4-acre site, manufactures various small electrical components such as fuses, relays and switches. Given the discovery of the industrial solvent and cleaner, trichloroethylene, a dense

non-aqueous phase liquid (DNAPL) in groundwater below the property, the site is under a voluntary cleanup and ground water monitoring order as per US EPA ². According to US EPA records, the site has undergone “clean closure certification” as of March 2005. A Human Exposure report detailing the events at the site with monitoring results claims the site did not and does not pose any credible adverse public health risk ³. The final US EPA order for closure is anticipated in 2016. Given the lack of a clear human exposure pathway, it is very unlikely any organic materials (DNAPLs) have substantially impacted air, water or soil in Vieques. See photos

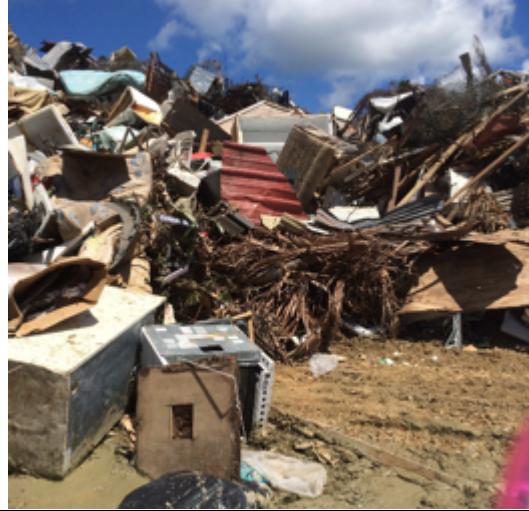
Solid Waste Facility

SOLID WASTE MANAGEMENT FACILITIES: The team identified one solid waste management facilities (sanitary landfill) due east of the main village of Isabella (Lat/Long 18.14929, -66.41660). This facility is the sole solid waste handling site for Vieques and consists of several distinct disposal sites; namely an e-waste site, a putrescible garbage site, an organic/yard waste site and an automotive/metals disposal site. Each site was visited and visually assessed as well as tested for heavy metals in soil, mercury vapors in air and radiological materials. Our assessment yielded no apparent source of organic or inorganic materials of environmental consequence as well as no radiological materials. Given the lack of any contamination source as well as the distance from any appreciable population receptor, it is very unlikely any material from these waste management sites has impacted air, water or soil in Vieques.

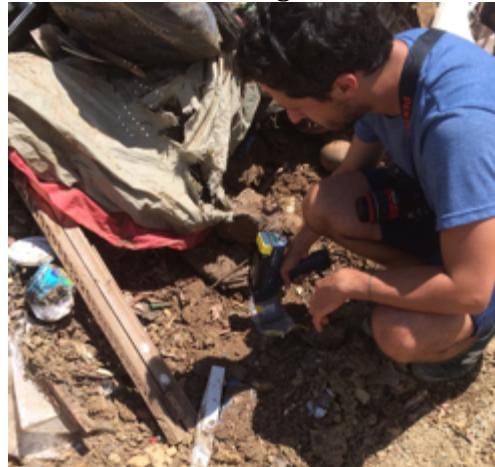
XRF Soil Testing for Metals

SOIL METALS CONTENT: Thirty-one XRF readings were taken from the various sites listed above. For Arsenic, Cadmium, Chromium and Mercury all soil samples were non-detects (i.e. <LOD). The lead in soil content varied from non-detectable (16 readings) to 105 ppm (US EPA guideline – 400 ppm). Lead is not a cancer causing substance.

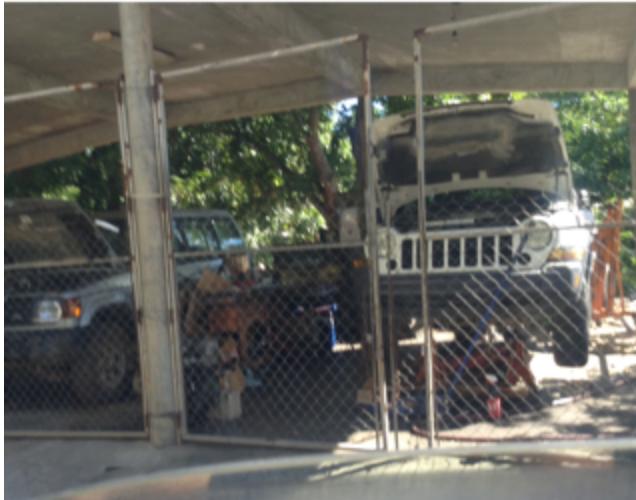
Automotive Repair Shop (informal)

AUTOMOTIVE REPAIR FACILITIES: Several residents and officials of Vieques informed us of the presence of several private and unlicensed auto repair shops in the surrounding villages. These shops are dispersed somewhat randomly throughout the

center region of the island and range from small (2-4 cars in the “shop”) to large (6+ automobiles) on an acre of more of land. Approximately 6 auto repair sites were discovered with others possible. No noticeable odors were present during our investigation of these sites. Given the private nature of these businesses, sampling was limited to the public portion of the road outside these sites. While the shops likely created occupational health risks and chemical exposures to the operators and residents living at the site, general population exposures were unlikely. Given the lack of any significant contamination source and the limited population at risk, it is very unlikely any material from these repair shops significantly impacted air, water or soil in Vieques. See photos

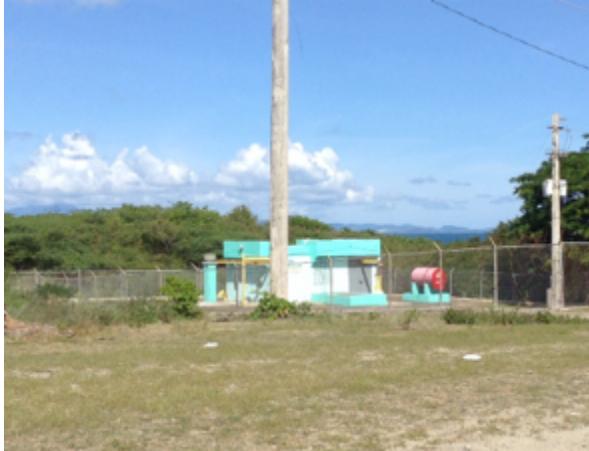
Drinking Water Pumping Station

WATER PUMPING STATIONS: While all potable water is delivered to the island via underwater pipeline from Puerto Rico, the distribution of water to villages necessitates the use of local pumping stations and storage tanks. There are numerous small pumping stations on the islands with many using diesel powered engines for backup pumps. These sites were all fenced off and appeared well manicured and maintained. Fuel storage tanks were well labeled and surrounded by secondary leakage containment. Given the lack of any significant contamination source and the limited population at risk, it is very unlikely any material from these drinking water pumping stations significantly impacted air, water or soil. See photo

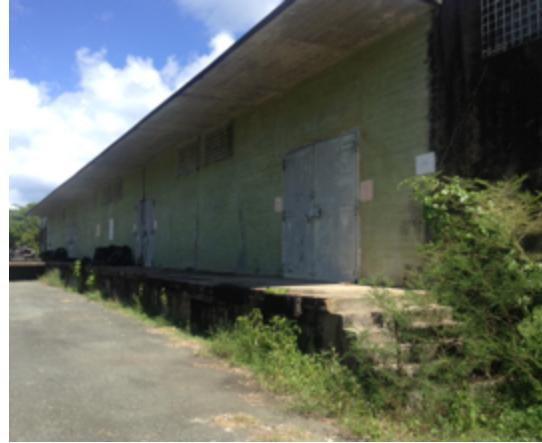
Abandoned US Navy Warehouse

GENERAL FIELD OBSERVATIONS: Lastly, the team travelled extensively to all regions of Vieques focusing special attention on residential and populated neighborhoods. Where there was a site with large vacant land, or a site with evidence of past buildings (i.e. old foundations) or a current industrial buildings the team conducted a careful and thorough visual inspection with periodic soil sampling. Given the lack of any significant contamination source and the limited population at risk, it is very unlikely any material from these properties significantly impacted air, water or soil in Vieques. See photos
