# Promoting Responsible Recovery and Handling of Mercury from Contaminated Artisanal Gold Mining Tailings in Colombia

*Laboratory Results of Tests of Mercury Recovery by Copper Plates  
Report February 2020*

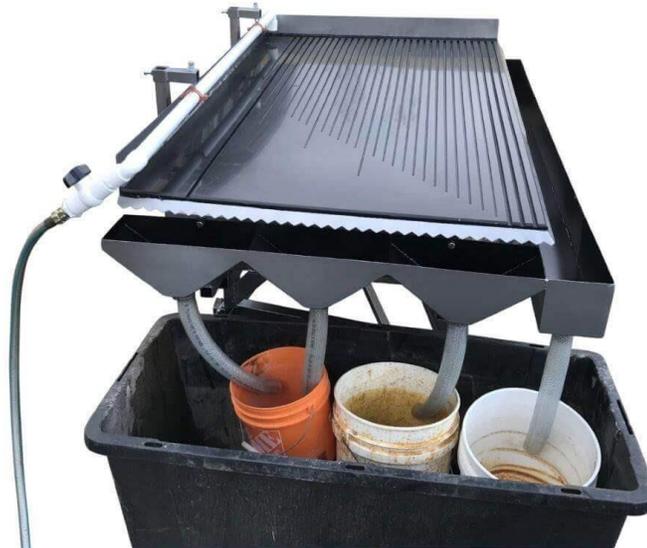
Figure 2. Vibration Table for tailings concentration.

Taking into account the capabilities and limitations of the equipment used in the test set-up and in order to be able to carry out standardized tests for all tailings, these were previously treated in a 30 and 70 mesh screen. This allows the removal of particles from large size that can intervene in the efficiency of the tests because the particles that are retained in each one of the meshes are discarded and nothing else is worked with the through material. It is important to mention that at this stage of the process, a thorough washing of the materials to be discarded was carried out to ensure that no mercury losses were generated. Likewise, the tailings were concentrated by a vibrating table, for which it was possible to obtain two types of tailings for San Roque in which they were determined as concentrate and others as means, each of them had the same test processing protocol. The vibrating table classifies minerals according to their specific weight, in this way the heaviest materials such as sulfides, gold and mercury remain in concentrates. In the media are the materials whose specific weight is less than those of the concentrates. The table does not separate by size, however, it is important that the food on the table has a uniform size since, if a mineral has little specific weight, but is large, it can go into the concentrate stream and contaminate them. This is why a stage prior to concentration is classification as explained above.

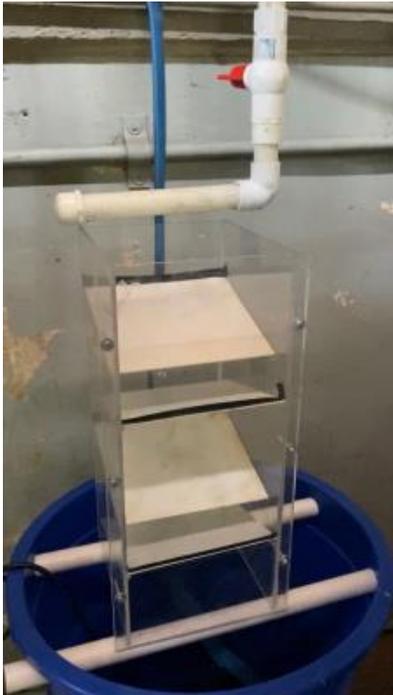
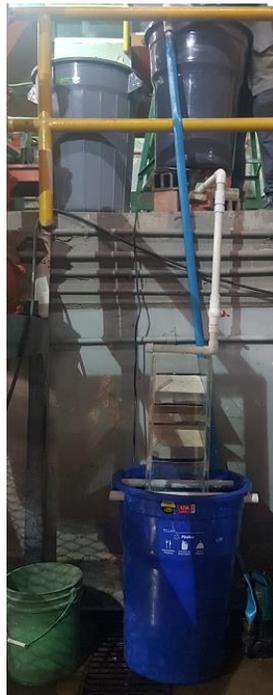
Figure 5. (a) Positioning of cascade copper plates. (b) Installation of Test operation. (c) Passing the tailings solution through the plates.

Due to the amount of available tailings, it was possible to carry out the comparison test with the two types of plates (with potential and without electric current potential) only for the Soto Mayor tailings, the others only worked with powered plates. Figure 5 shows the assembly made and some illustrations of the process carried out.

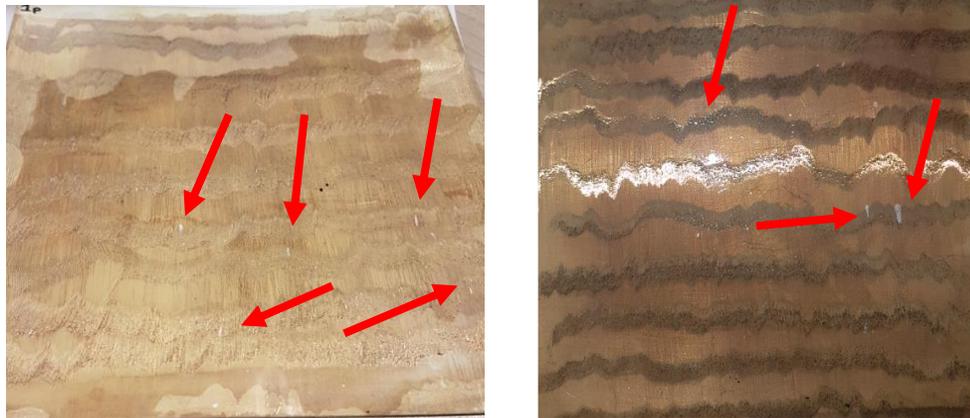
Figure 6. Mercury spots identified on the copper plates.

- At the end of each one of the tests, a reading of the XRF was made on the copper plate in order to show if there was a presence of mercury on the surface. Indeed, it was possible to show high concentrations on specific points on the plate and bright gray. (Figure 6).
