Promoting the recovery and responsible management of mercury in contaminated tailings from artisanal gold mining in Colombia.

Interim Technical Report of Copper Plate Pilot Test Results, phase I

August - 2020

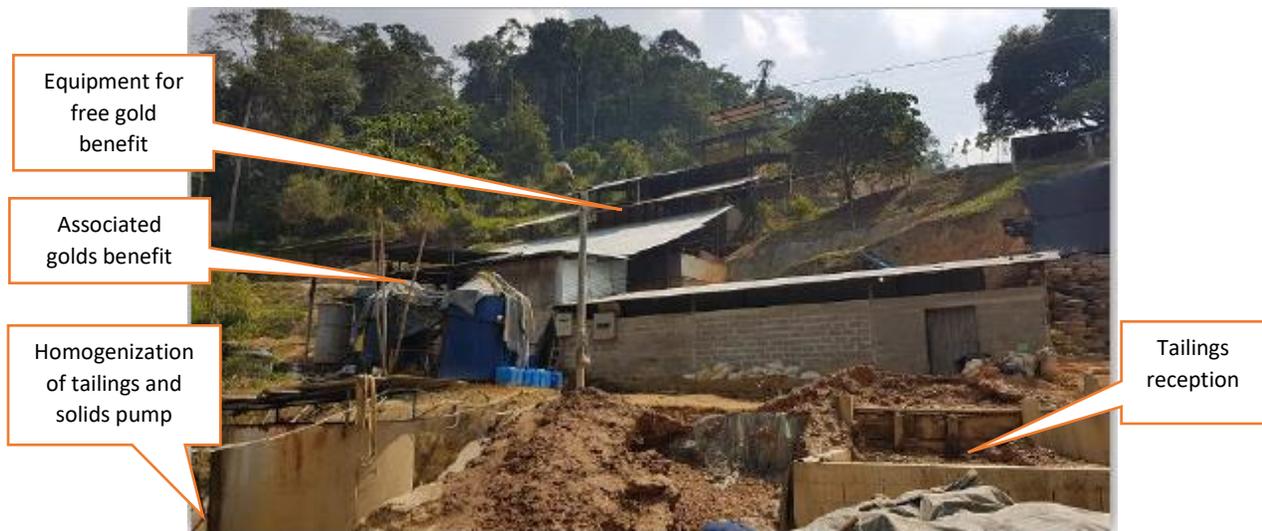
Figure 2. Processing plant in Yali

The Juan Diaz plant is equipped to realize the benefit of both free gold and associated gold. The construction of the installations takes advantage of the morphology of the land to use gravity in the passage of material from one stage to another, in the upper part of the plant (see Figure 2) are the equipment associated with the recovery of free gold, which, these are mechanical and gravimetric methods that do not use mercury for profit, and include crushers, mills and vibrating table, however, this part of the plant is currently in disuse.

At present the process begins with the reception of the tailings, the space for this activity is physically located at the base of the facilities (see Figure 2), the tailings are wetted with water and dragged to the filter and solid pump, which, it takes the now-called slurry to the flotation tank or directly to the cyanidation tanks, depending on the processing indications.

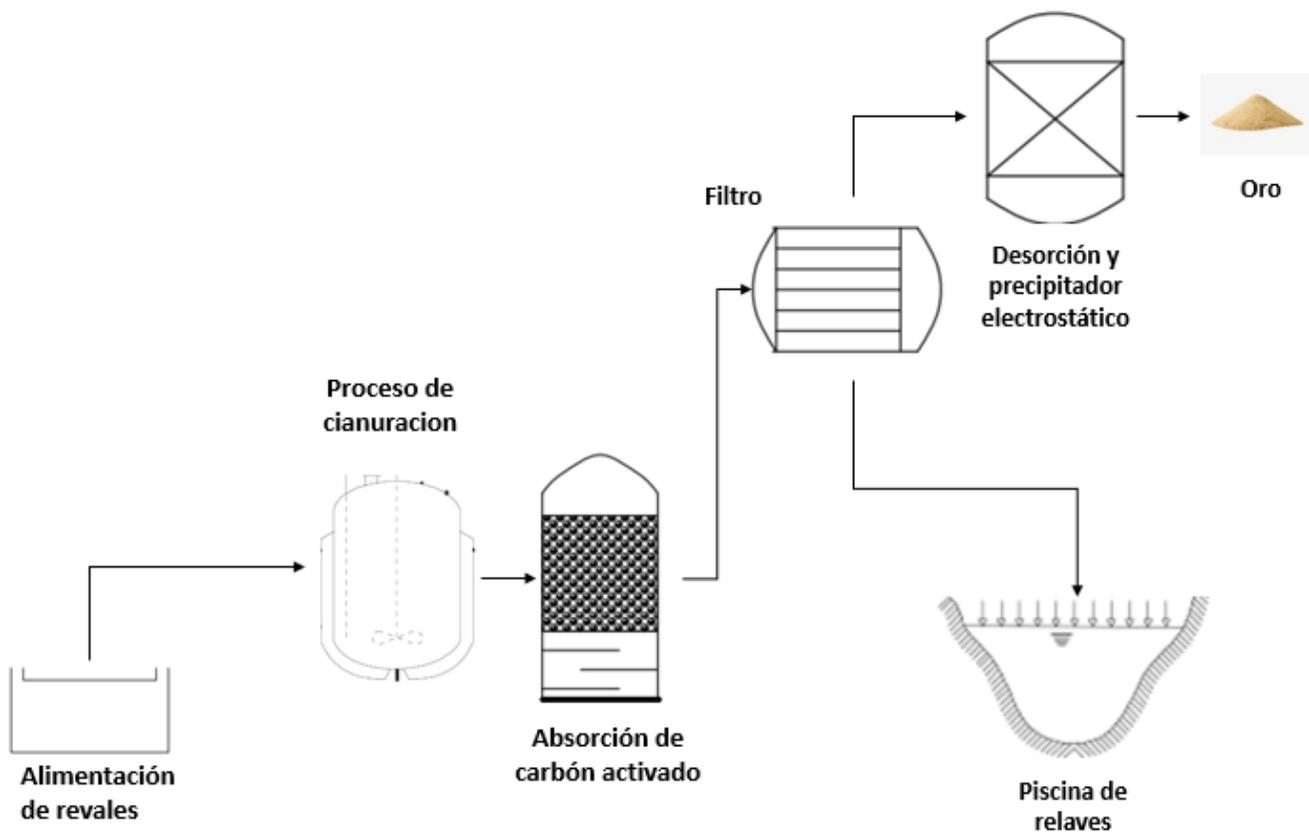
Figura 1. Proceso de la plata piloto

passed, which is not continuous, i.e. electrochemical desorption is performed by accumulation of treatment of several tailings over a period of time. At the end of the process the tailing is taken to the pool. Figure 3 shows a schematic of the gold extraction process of the plant.

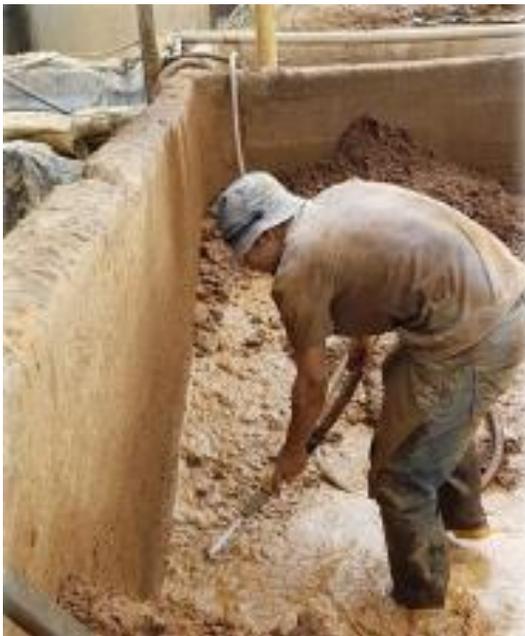
Figure 4. Tailings feeding

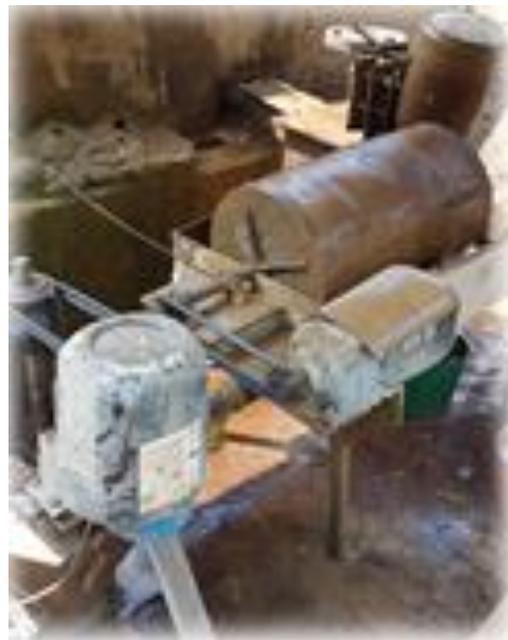
Figure 2. Soil pumps

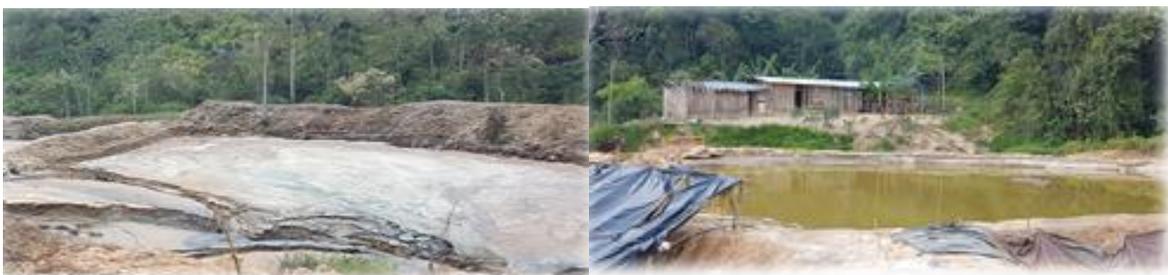
Figure 3. Tailings pool

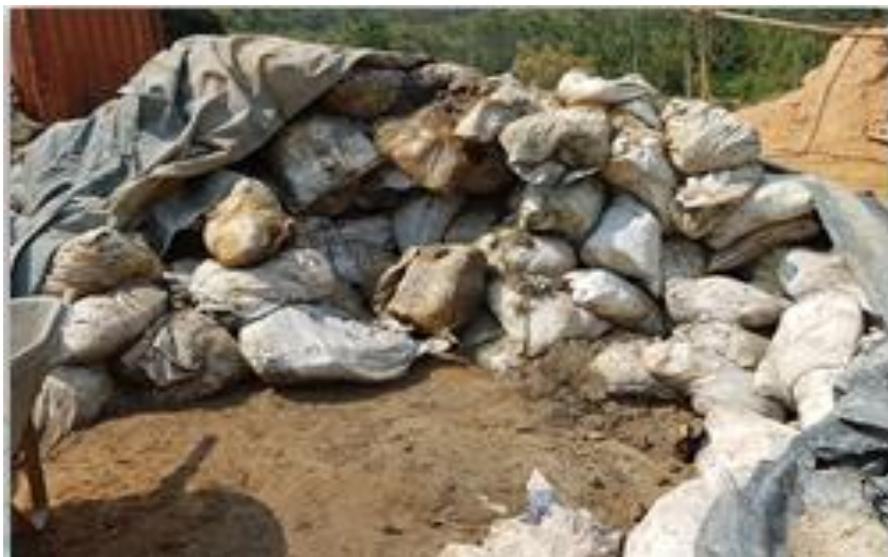
Figure 4. Tailings used in the process

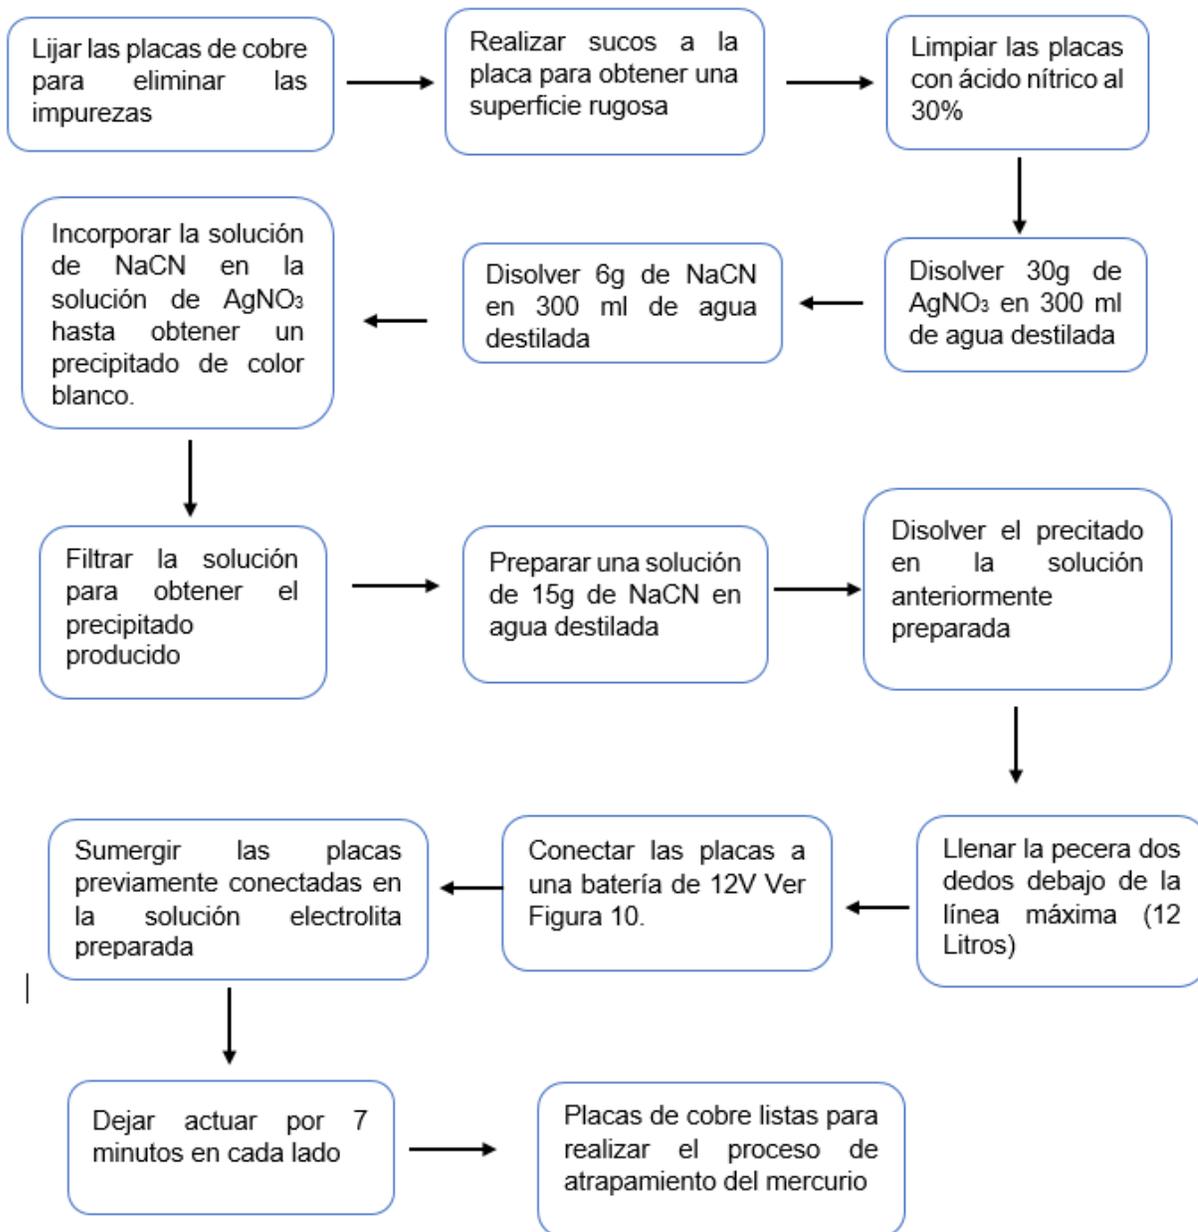
Figure 6. Procedure for the manufacture of copper plates amalgamated with silver

The overall manufacturing process of the plates is described in Figure 6.

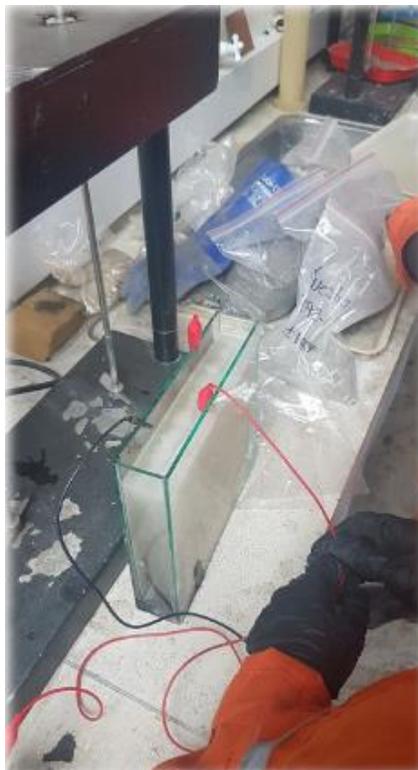
Figure 7. Assembly of the electrolysis process

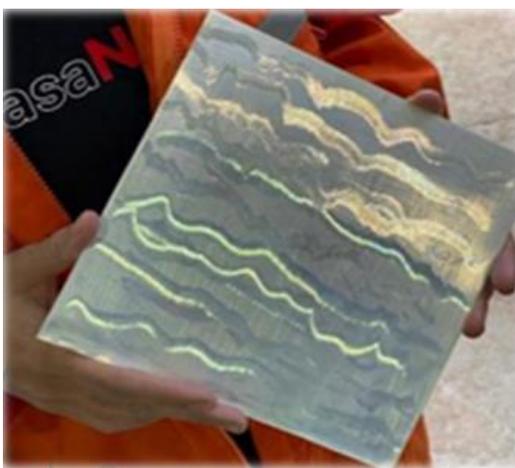
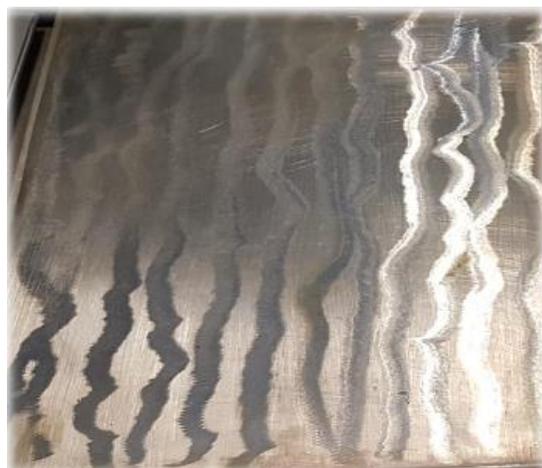
Figure 8. Results obtained silver copper plates

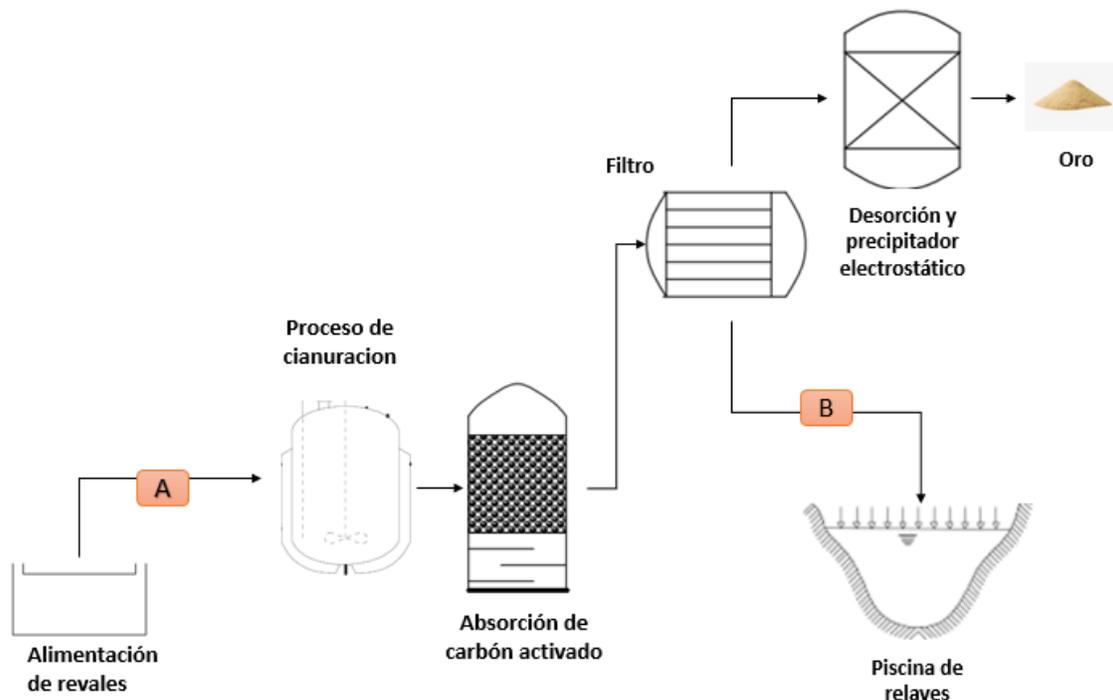
Taking into account that the main purpose of the use of copper plate technology corresponds to removing mercury before the tailings beneficiation process to obtain residual gold, one of the plate sets was installed just before the cyanidation process (point A), which is currently being developed by the Juan Díaz plant. Likewise, to estimate the efficiency of the process, the other set of plates was installed at the exit of the process and before the deposit in the tailings (Point B), as shown in the following figure.

Figure 9. Location of copper plates in the process

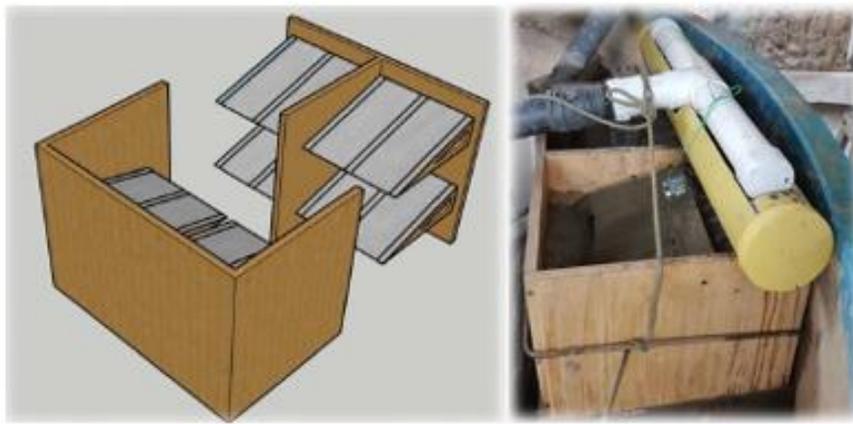
The plates must be installed on a support to ensure the passage of the pulp through the plates. The installation of the plate support at point A was carried out on the top of the cyanidation tank where a flow distribution circuit was adapted at the inlet of the plates, so that the fall of the tailings solution had contact over the entire extension of the plates, as seen in the following photographs.

Figure 10. Copper plate support module and flow distribution circuit

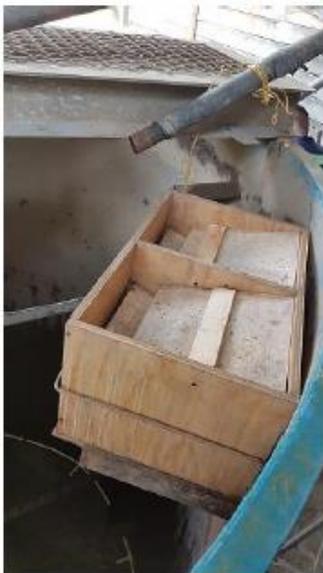
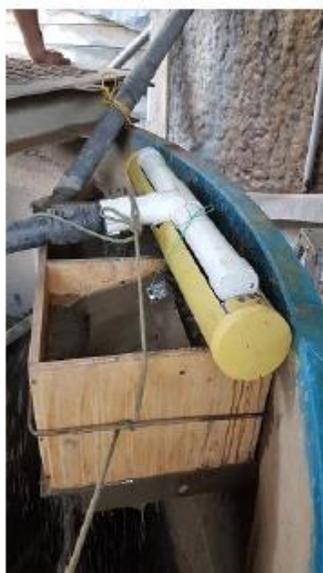
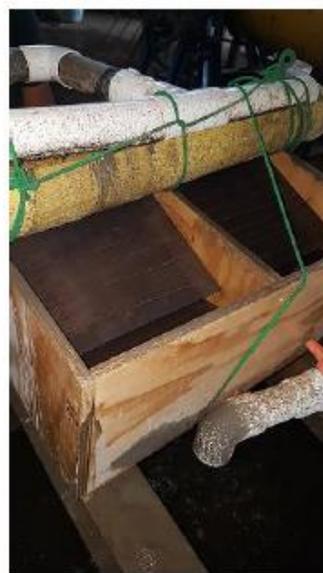
Figure 11. Location of the media at Point A. Before the cyanidation process

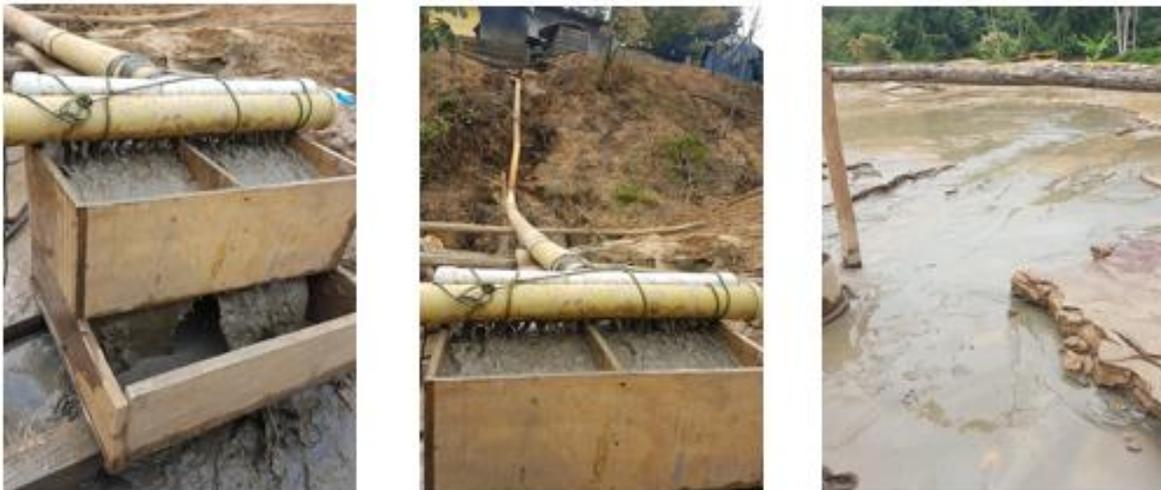
The installation of the plate support at point B was carried out taking advantage of the difference in height of the last process (filter) in relation to the tail pools. Likewise, the same flow distribution circuit was used at the entrance of the plates, so that the fall of the tailings solution had contact over the entire extension of the plates, talc as can be seen in the following photographs.

Figure 12. Location of the media at point B. After the cyanidation process

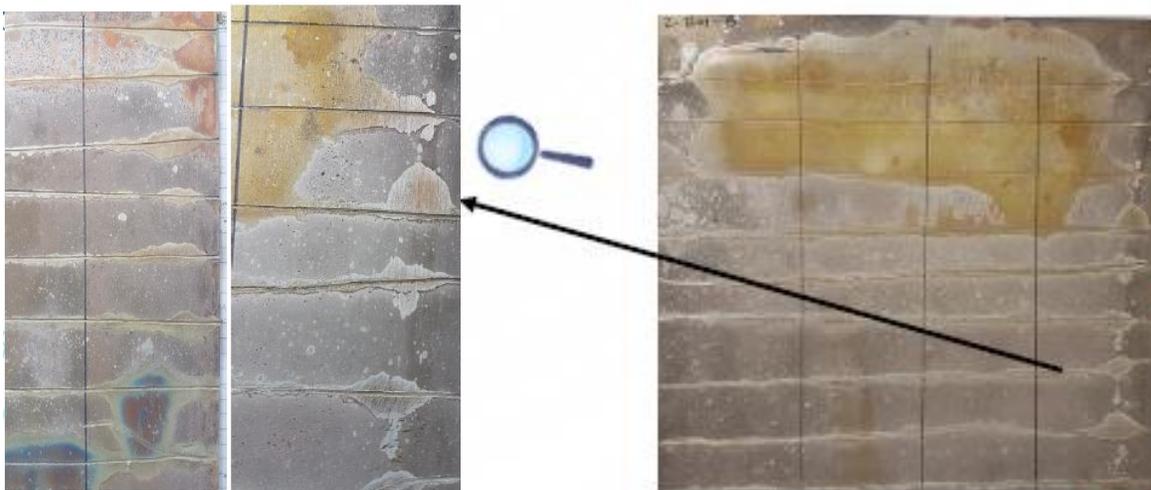
Figure 13. Copper plates point A after the process

At the time of making the measurements on the plates, it is evident that a greater concentration is found in the grooves of the plate, so it was decided to make the measurements of the plates of point B directly in the grooves where the following results are obtained.

Plate Nro	Average concentration Hg (ppm) on copper plates
1	56,2
2	183
3	118
4	68,8
5	118
6 *	1,717

* This value was taken on one of the grooves of the copper plates and not on the smooth surface as was done in the other readings reported in this table.

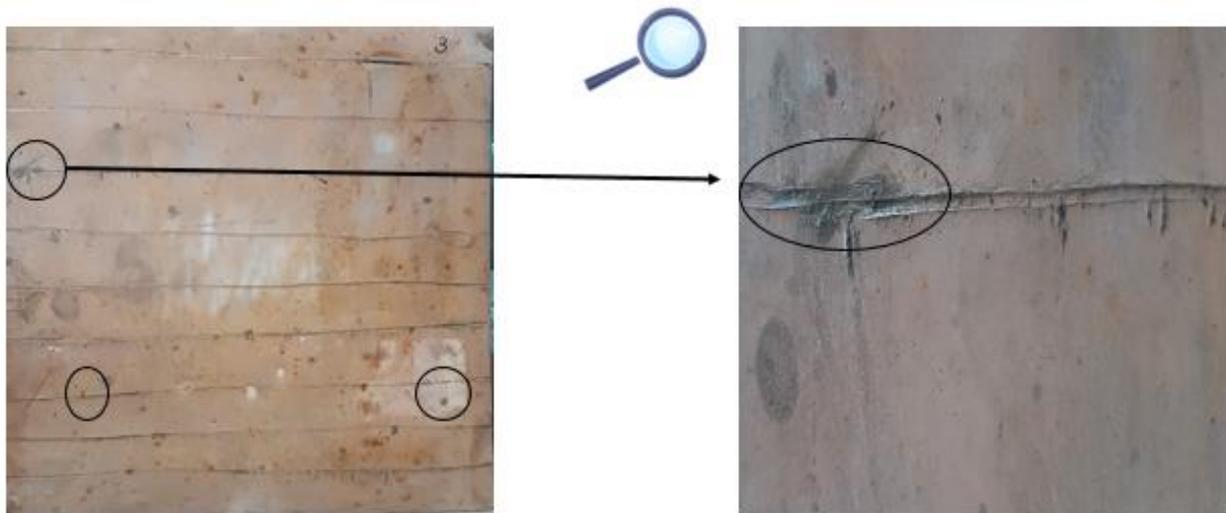
Figure 14. B-spot copper plates after the process

Plate Nro	Average concentration Hg (ppm) over the grooves of copper plates
1	39,130
2	63,623
3	26,959
4	22,101

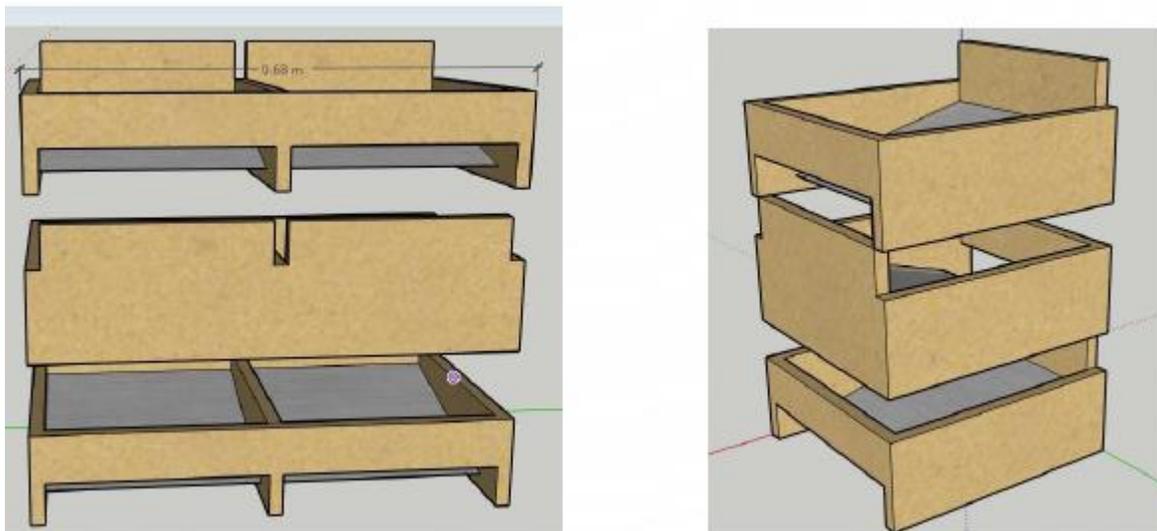
- Pending development of pilot tests of Phase II and III, it is barely possible due to issues of mobility restrictions due to the pandemic situation. (Estimated date from September onwards)
- Field control variables will be included to estimate the service life of copper plates. However, the plate washing process continues as an option within the process.
- Adjustments will be made to the plate plating process by testing tin as a support part on the copper plate.
- The support module of the copper plates will be optimized, so that it is more functional and allows rapid changes in the field, increasing the surface area of contact between the tailings and the plates.

Figure 15. Prototype copper plate support module
